# Electromagnetic Interference with Implantable Cardioverter Defibrillators Causing Inadvertent Shock: Case Report and Review of Current Literature

TYPE: Case Report

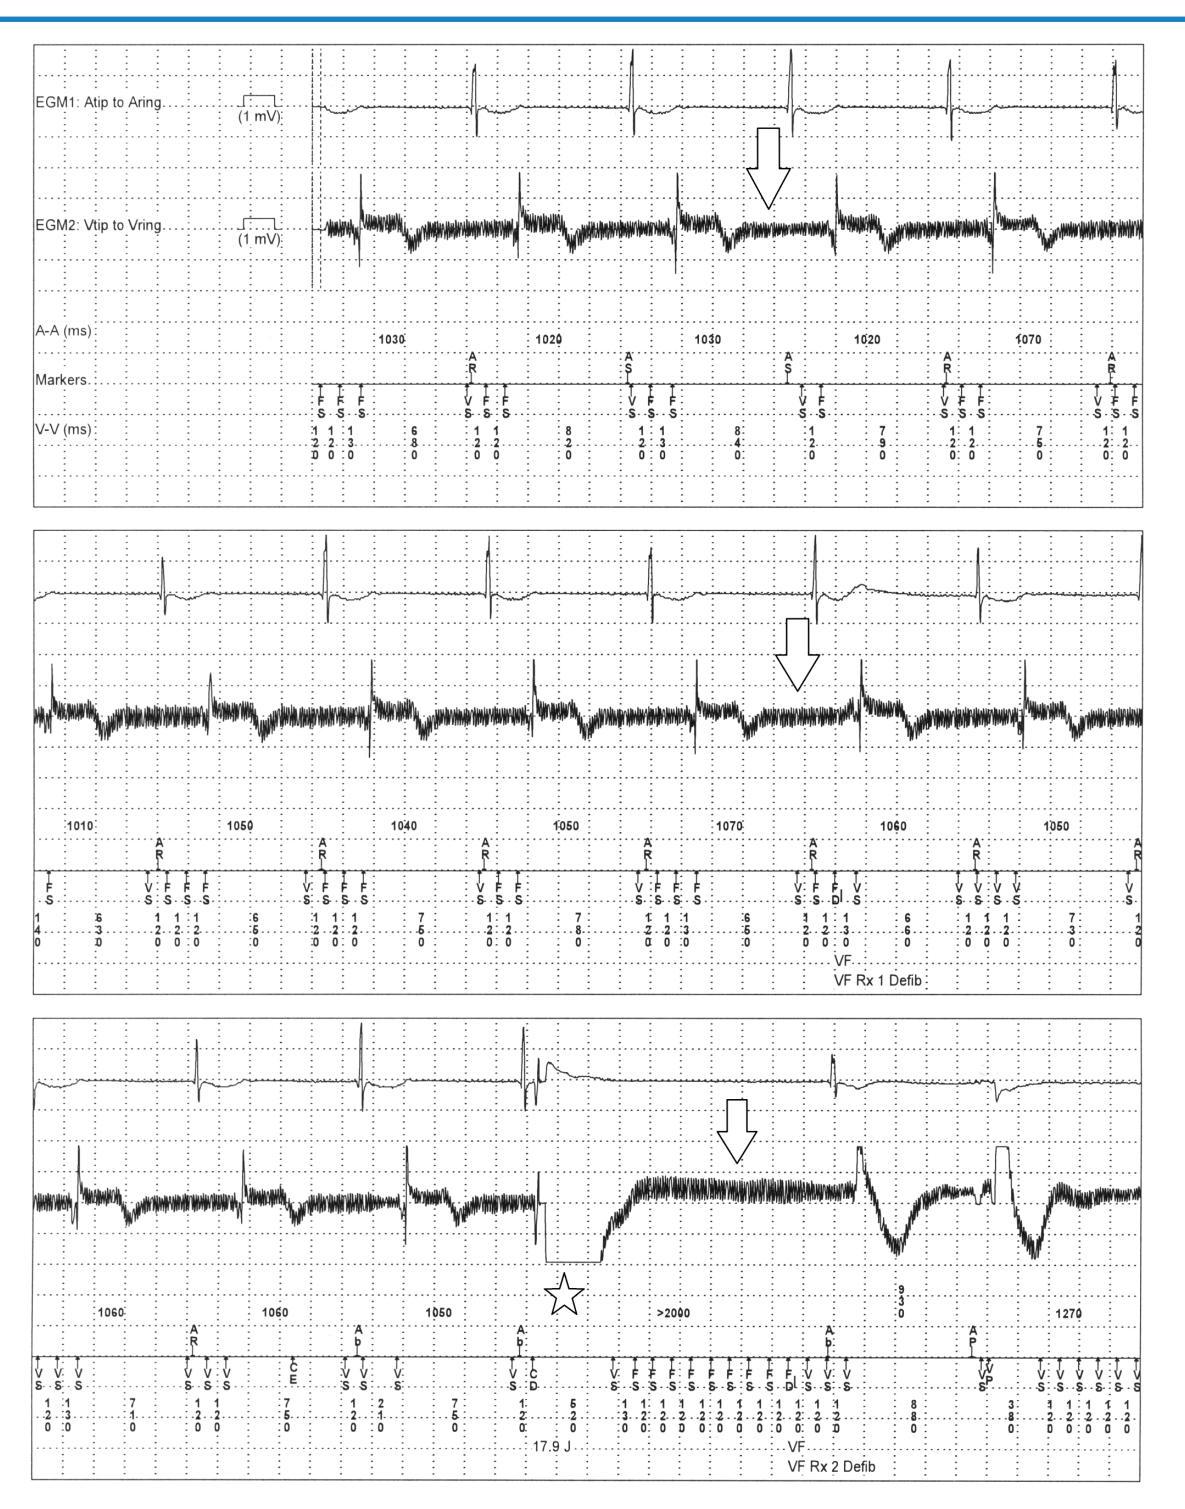
examination was normal. From the ICD interrogation done in his cardiologist's office, the device was programmed to detect ventricular fibrillation (VF) at > 188 bpm and ventricular tachycardia (VT) between 162–188 bpm. Sensitivity was programmed to 0.3 mV. Pacing lead impedance was 272 ohms and defibrillator lead impedance was 39 ohms for RV and 52 ohms for SVC. Stored intra-cardiac electrograms recorded during this event showed high frequency undulating noise consistent with 60 Hz alternating current (Fig. 1). This was interpreted by ICD as VF and was shocked three times (Fig. 2). The pool was examined by a certified electrician who found a small leak into the pool from a lamp. The problem was fixed. Patient was counseled to be careful handling electrical equipment.

Figure 1. Intra-cardiac electrocardiograms recorded by the device during the event showing, high frequency electromagnetic interference in the background of normal QRS morphology (White Arrows), shocks delivers during this event (marked as stars), black arrow denotes the time when patient came out of pool and shows disappearance of EMI with no further shocks.

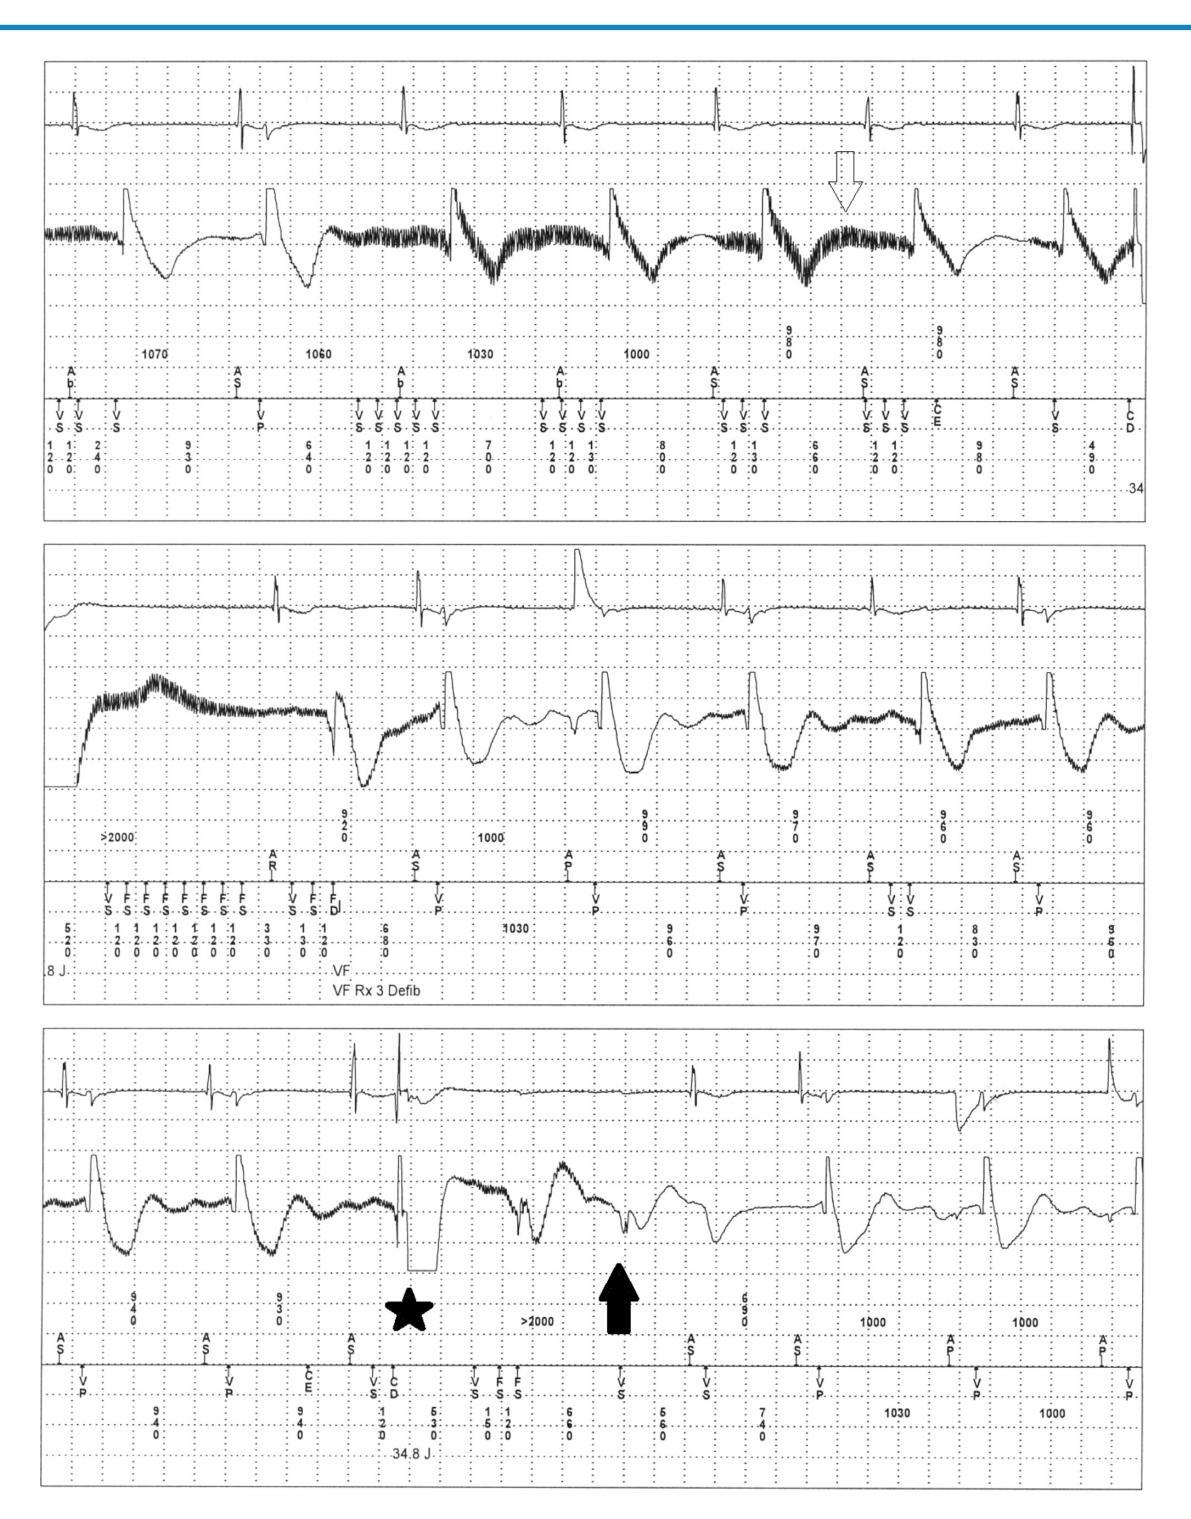
Figure 2. Intra-cardiac electrocardiograms recorded by the device during the event showing, high frequency electromagnetic interference in the background of normal QRS morphology (White Arrows), shocks delivers during this event (marked as stars), black arrow denotes the time when patient came out of pool and shows disappearance of EMI with no further shocks.
